RESEARCH ON GROWTH OF MICROCRACKS IN NICKEL-BASE SUPERALLOYS

Southwest Research Institute
P. O. Drawer 28510
San Antonio, Texas 78284

TECHNICAL REPORT AFML-TR-78-133
FINAL REPORT FOR PERIOD 1 JUNE 1976 to 30 SEPTEMBER 1978

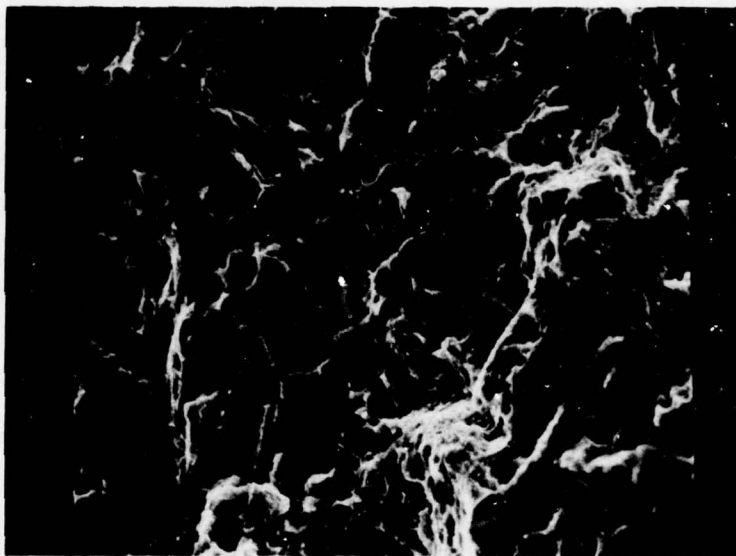
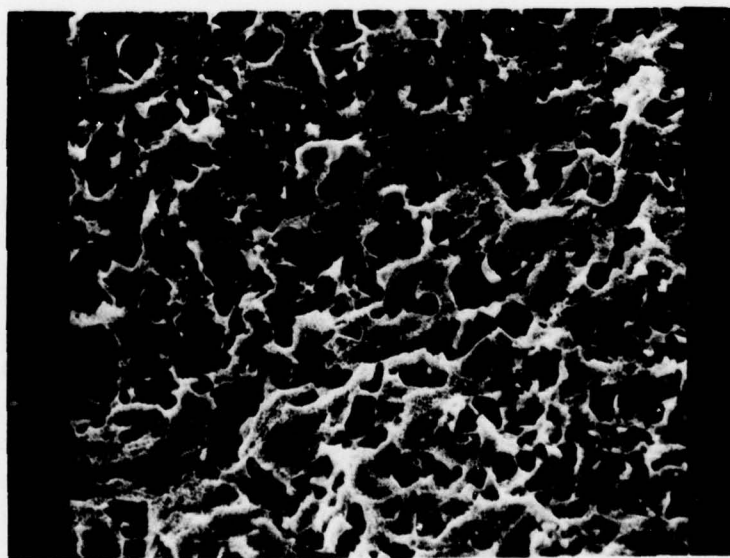
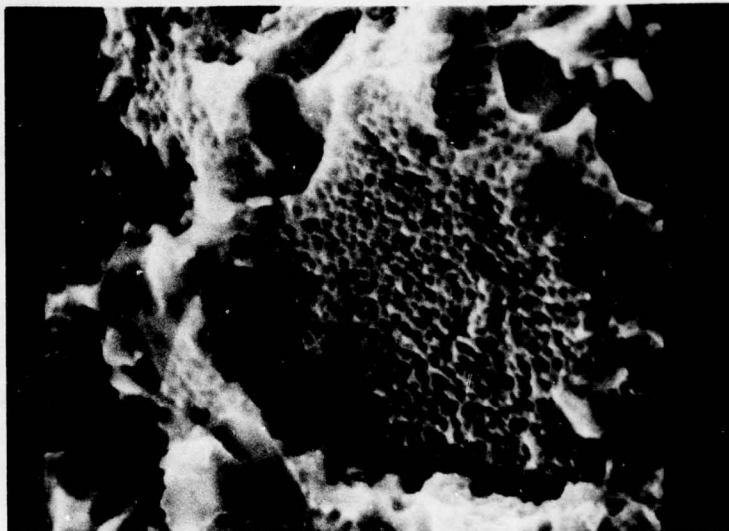
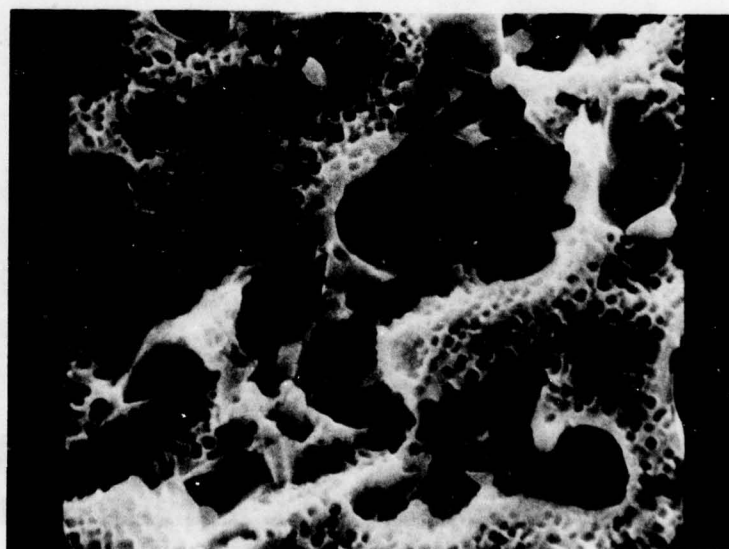
Figure 23a. Etched Crystallographic Fatigue Surface.
3000X

Figure 23b. Etched Striated Fatigue Surface. 3000X

Figure 23c. Higher Magnification View of 23a.
12,000X

Figure 23d. Higher Magnification View of 23b.
12,000X

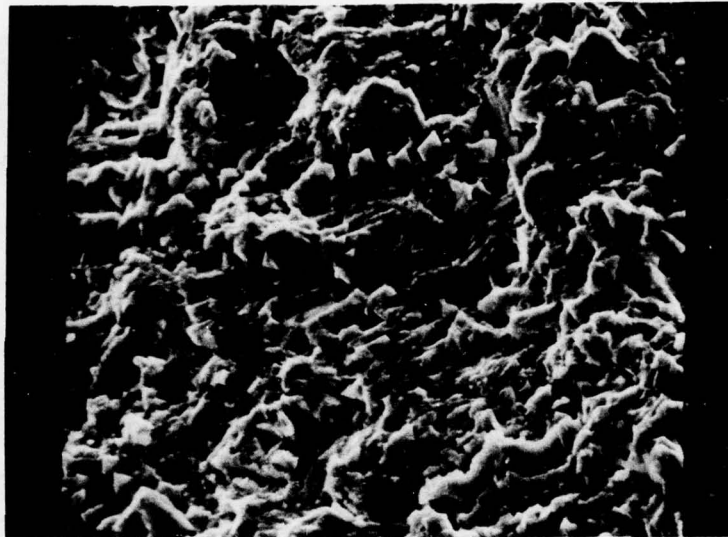
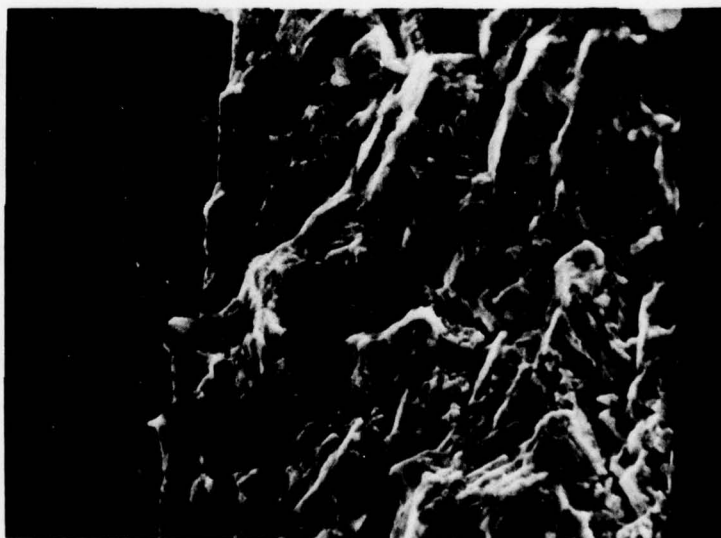
Figure 24a. Striations on Fatigue Surface.
2700X

Figure 24b. Crystallographic Region At Specimen
Surface. 2700X

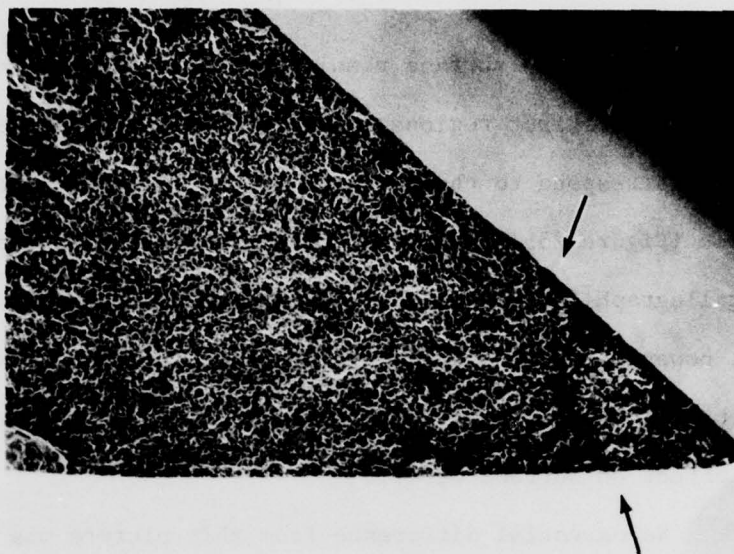
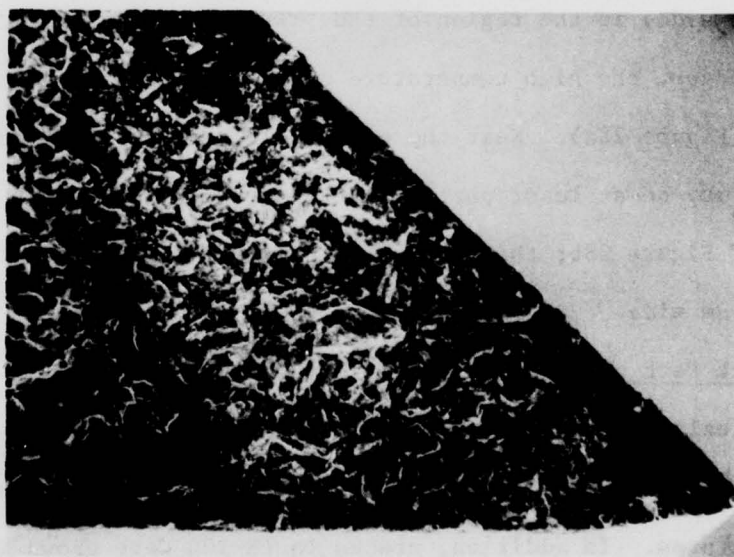
Figure 25a. Fracture Surface of 650°C Cyclic Specimen. 200X
Arrows Indicate Original Precrack Length.

Figure 25b. Comparison of Precrack and 650°C Fatigue Surface. 700X

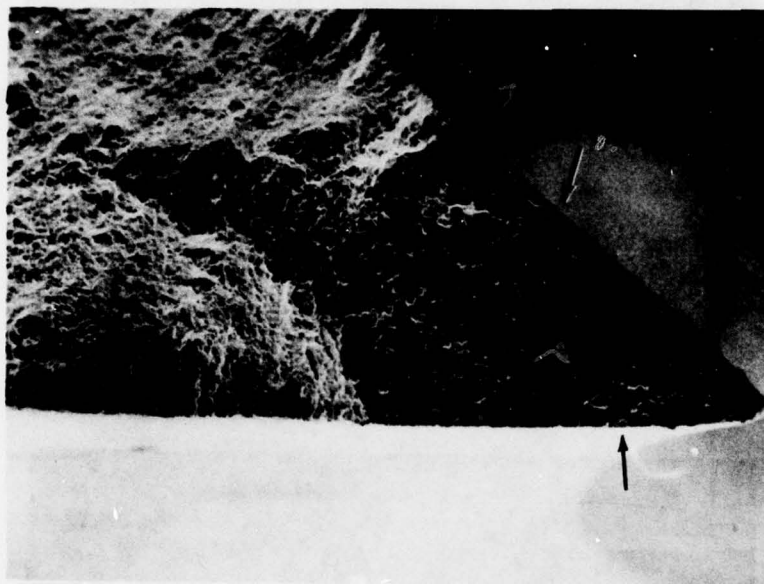
Figure 26. Fracture Surface of 650°C Dwell Specimen. 200X

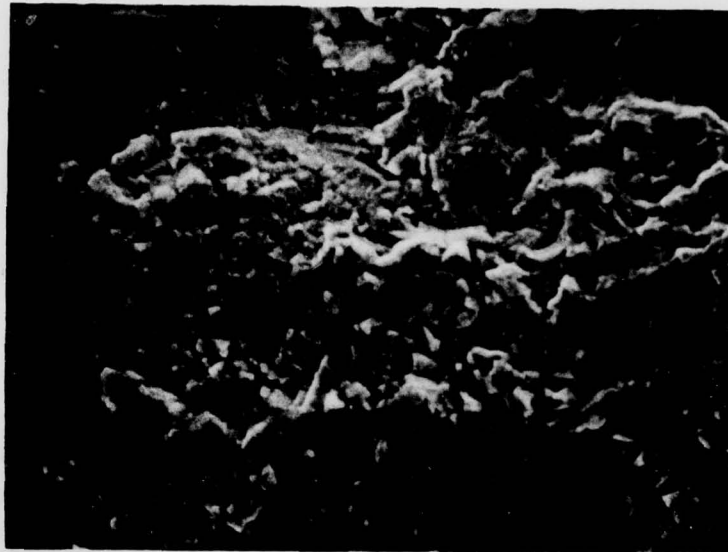
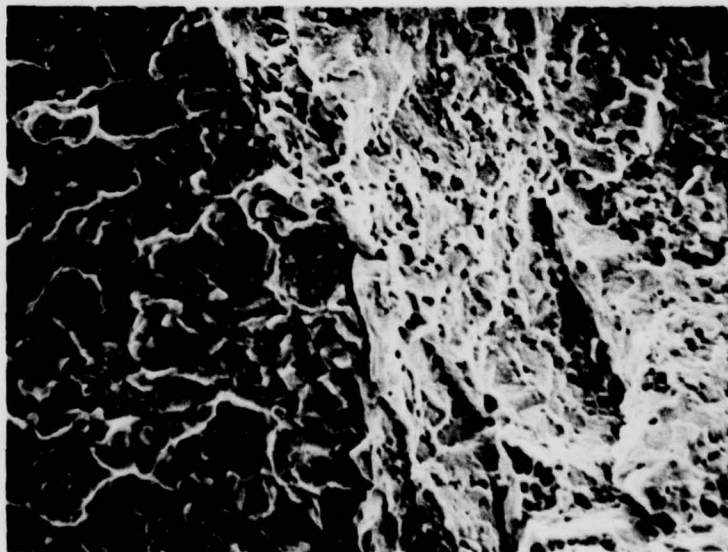
Figure 27a. Crystallographic Surface in Precrack Region. 1500X

Figure 27b. Comparison of Crystallographic and Intergranular Fatigue Surfaces. 1500X

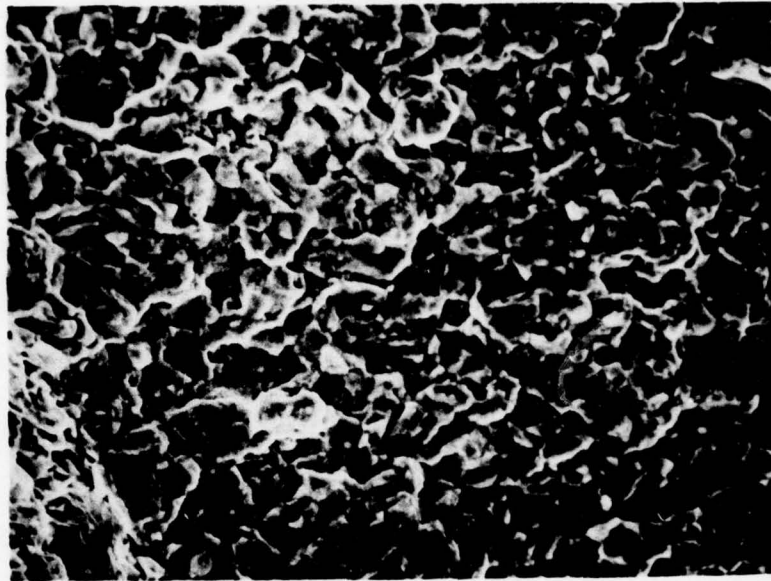
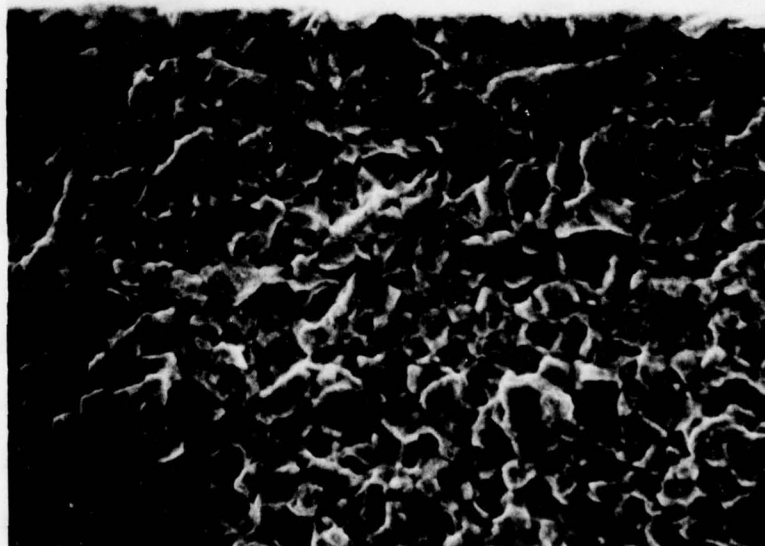
Figure 28a. Fatigue Surface, 650°C Dwell Specimen.
1500X

Figure 28b. Fatigue Surface, 650°C Dwell Specimen
Near Specimen Edge. 1500X

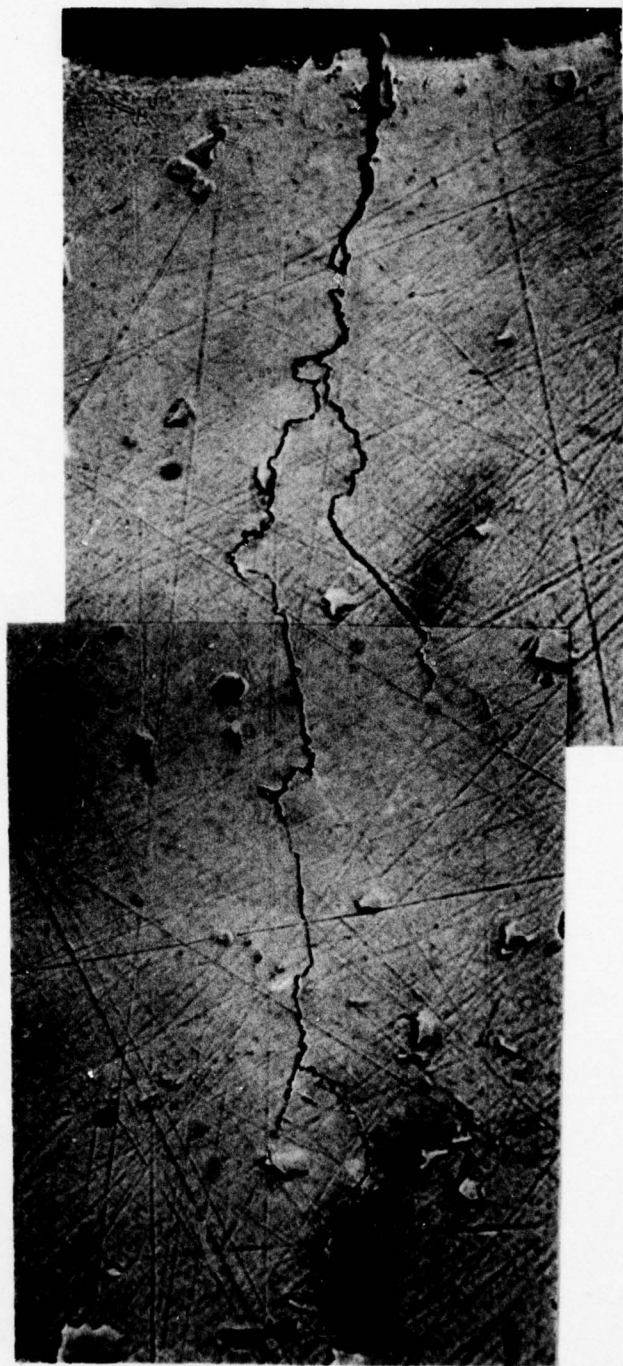
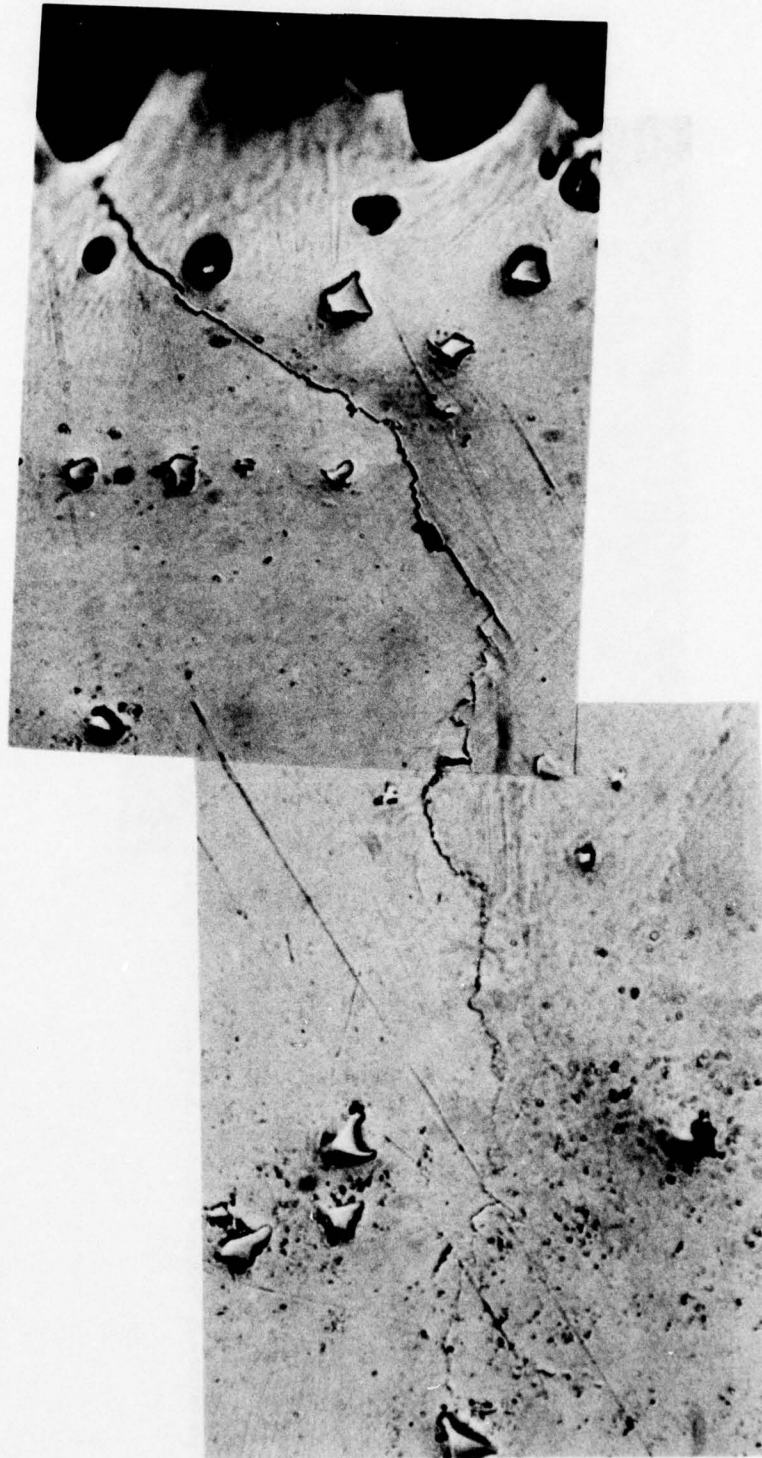
Figure 29a. Initial Crack Found in Rene' 95 Bending Specimen
#2 After 1.3×10^6 Cycles, Left Side. 645X

Figure 29b. Rene' 95 Bending Specimen #2, Right Side. 645X

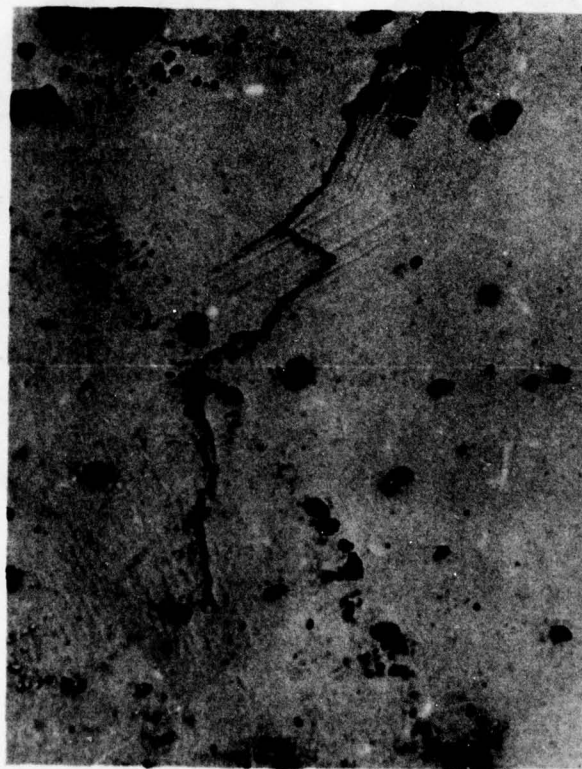
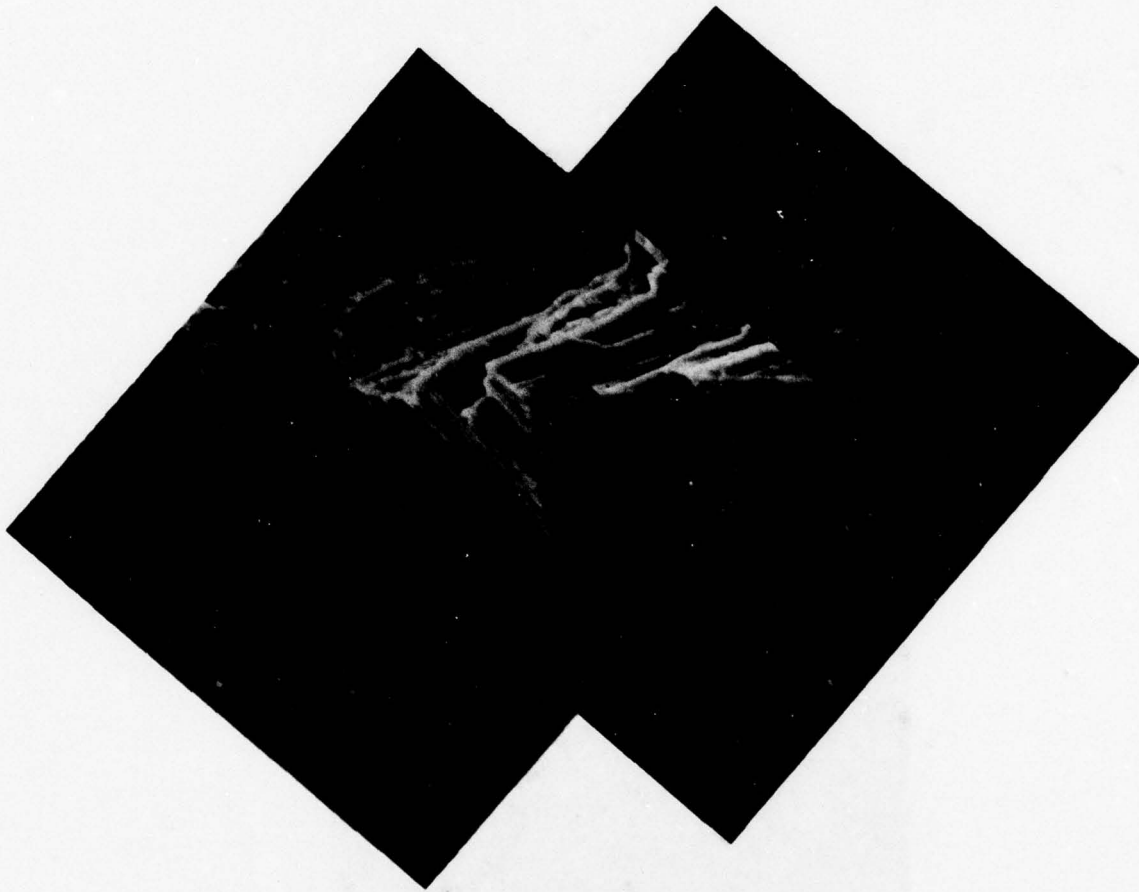
Figure 30a. Rene' 95 Bending Specimen #2, Right Side, Crack
Tip and Slip Lines. 320X

Figure 30b. Closeup of Region in Rene' 95 Bending Specimen #2
Showing Fracture Surface and Crack Crossing Slip Region.
2200X

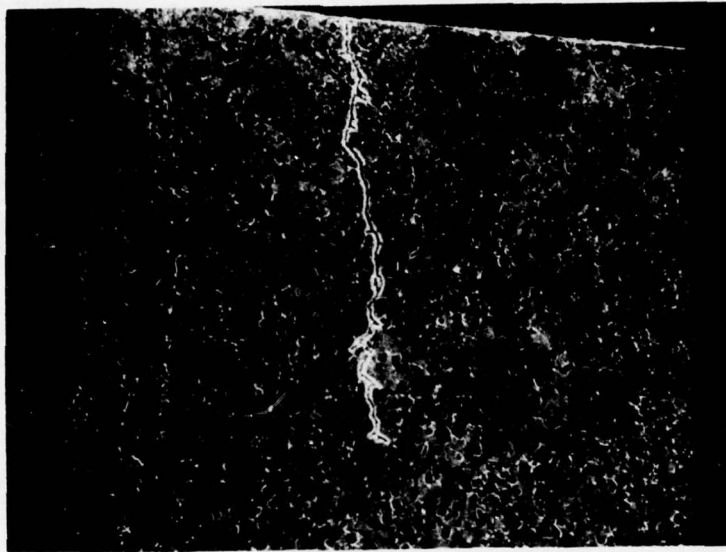
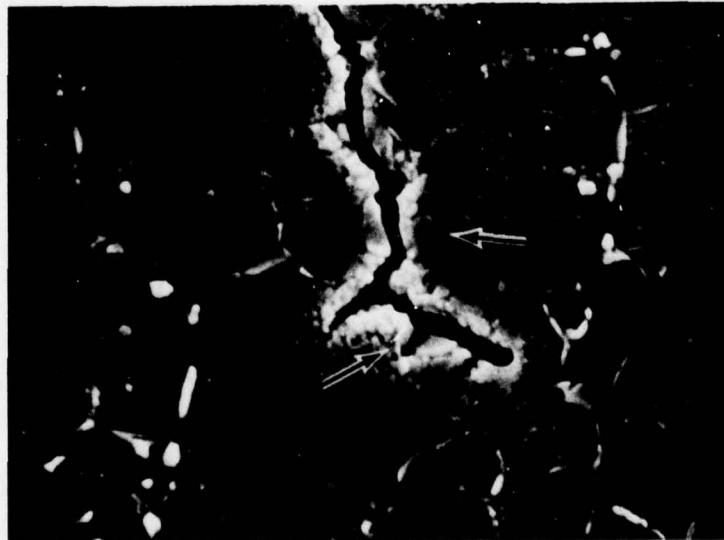
Figure 31a. Fatigue Crack in IN-100 Prior to Cycling in SEM. 600X

Figure 31b. Fatigue Crack Tip Prior to Cycling in SEM.
6000X
Arrows Indicate γ' Which the Crack Has Passed Through.

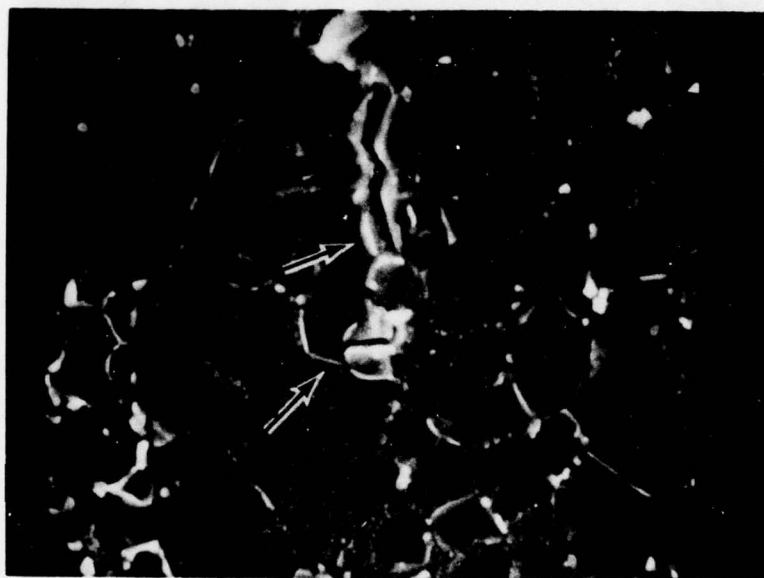
Figure 32. Crack Tip During Cycling
in the SEM. 4000X
Arrows Indicate γ' Particles.

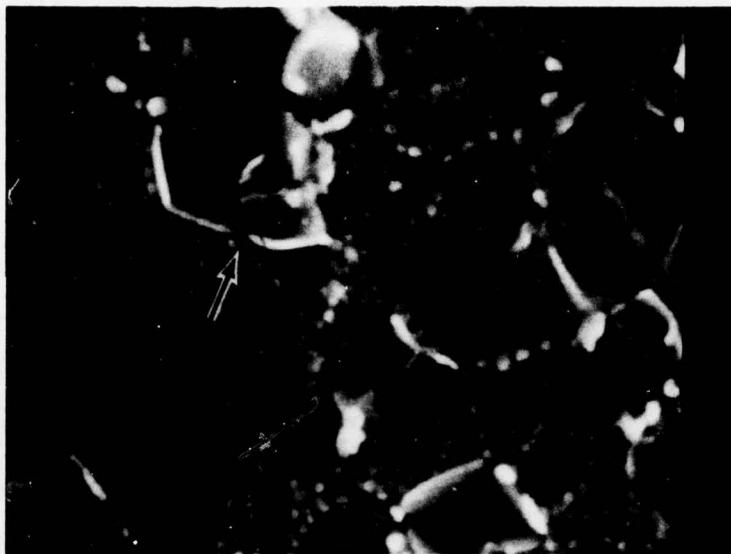
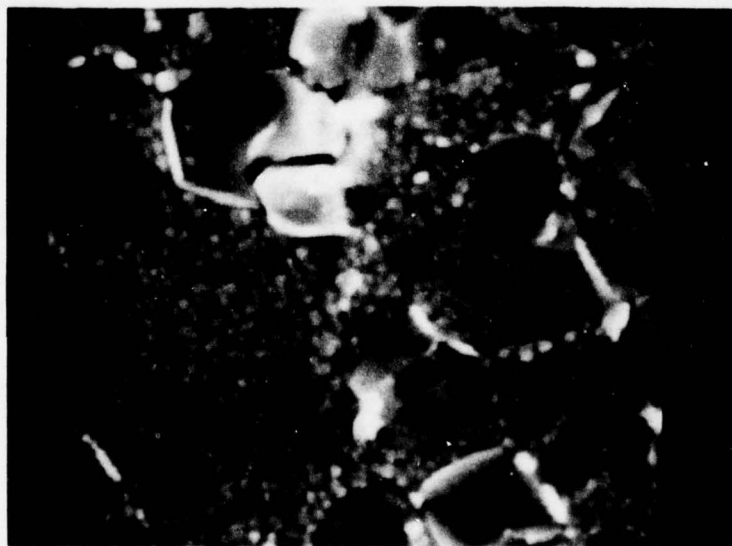
Figure 33a. Closeup of Unloaded Crack Tip.
8000X
Arrow Indicates Crack Tip.

Figure 33b. Closeup of Loaded Crack Tip.
8000X

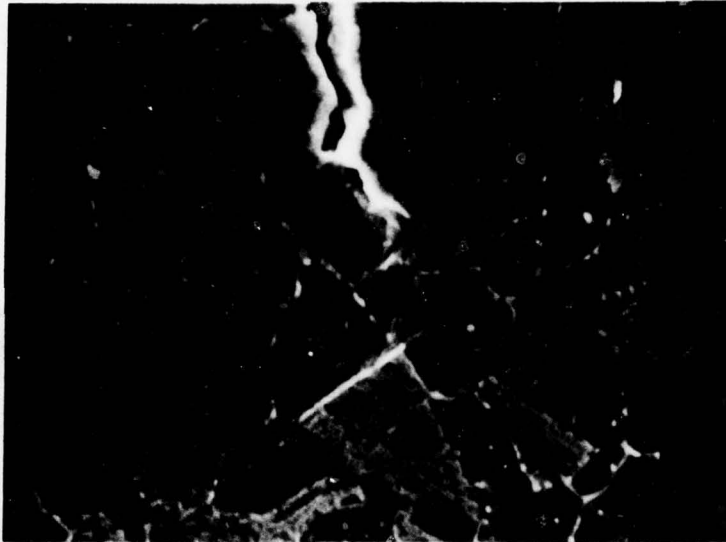
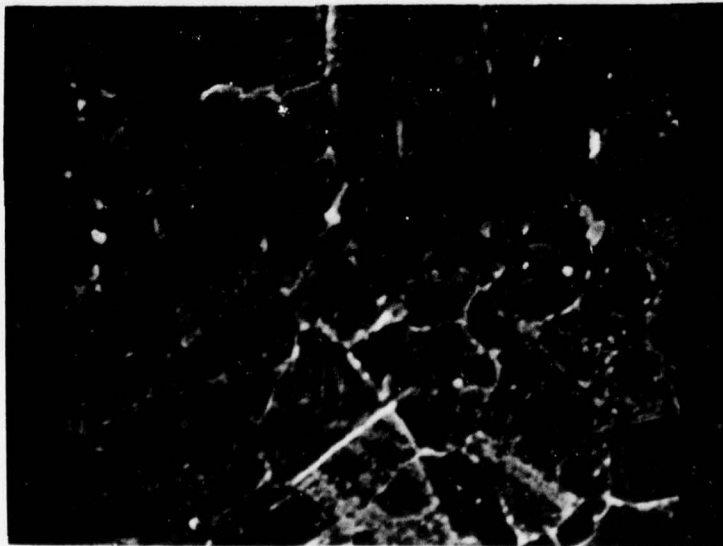
Figure 34a. Loaded Crack Tip for Crack Length
of 0.5 mm. 5000X

Figure 34b. Unloaded Crack Tip. 4000X

A typical example of this behavior is seen in Figure 34, which shows the growth of a "long" crack. As it turns out, the blunting/sharpening sequence is essentially identical for both "long" and "short" cracks, in agreement with the fractography results discussed earlier. Considerable microcracking occurs ahead of the crack tip (Figure 35), although the main crack may not link up with each microcrack (Figure 36--

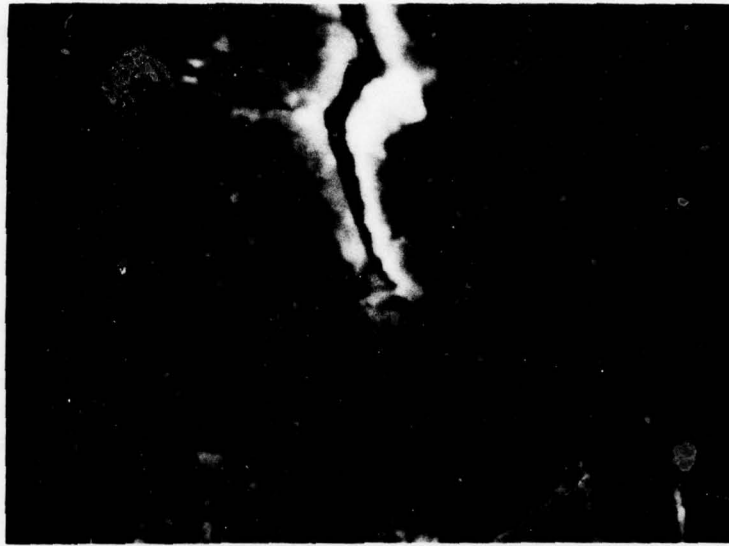
Figure 36a. Loaded Crack Tip and Associated Microcrack. 8000X

Figure 36b. Unloaded Crack Tip. 8000X

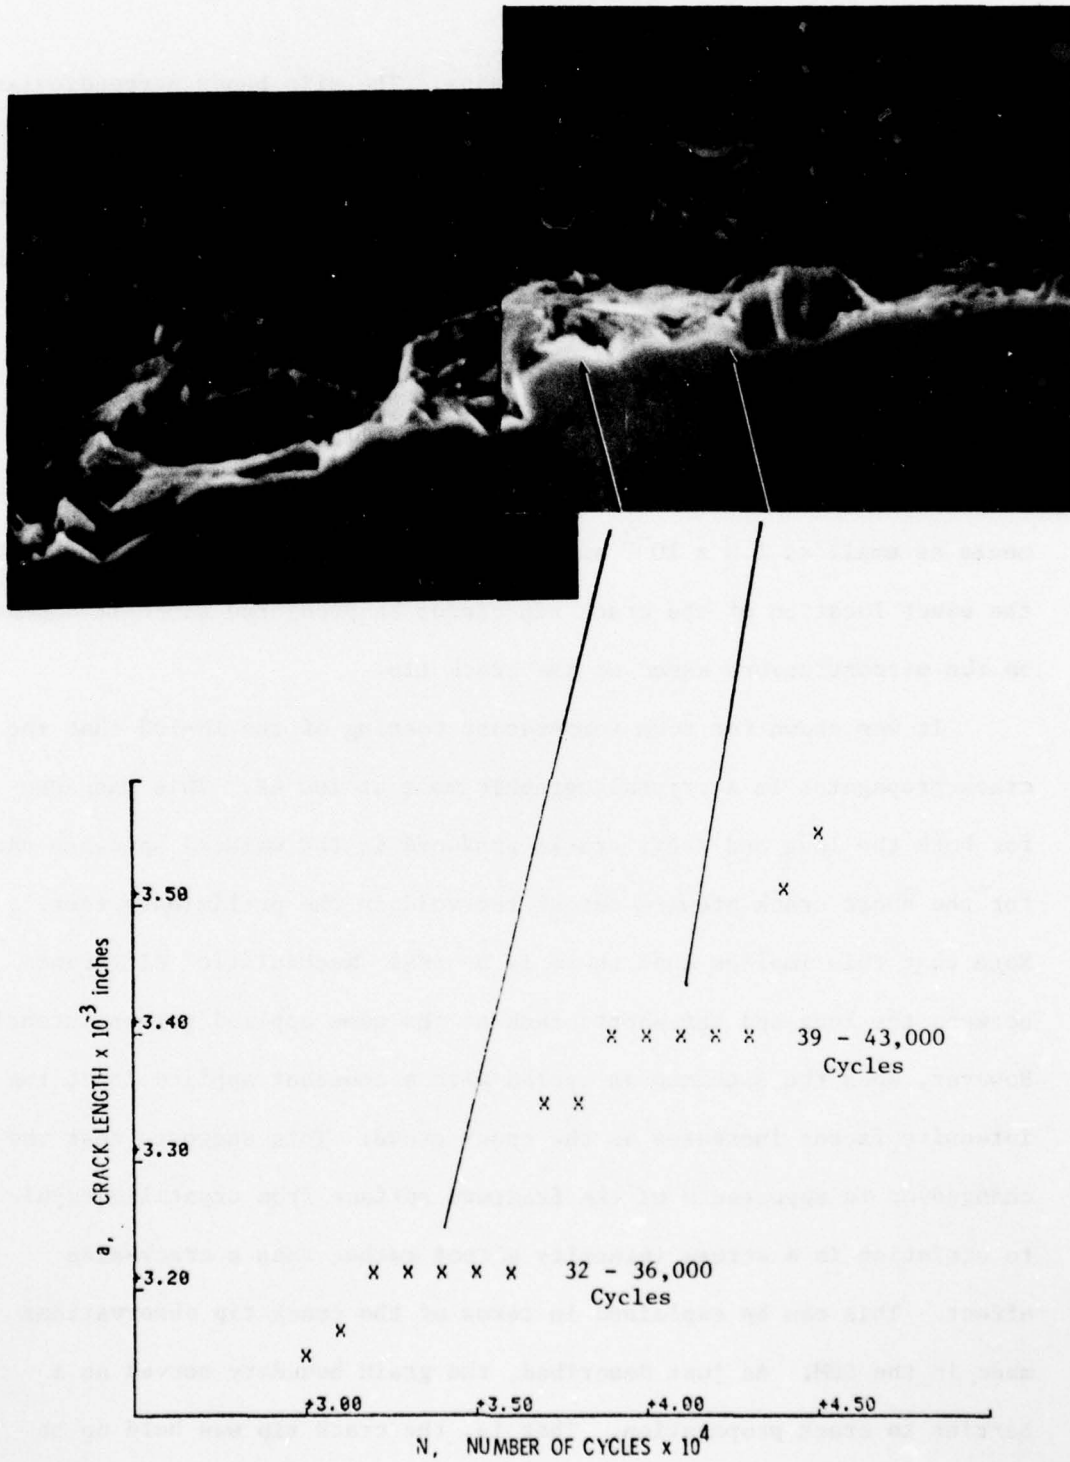
Figure 37. Correspondence Between Fracture Surface and Crack Growth Pattern

The results of our experiments indicate that it may not be possible to make generalizations about the applicability of linear elastic fracture mechanics without considering both the material and its mode of fracture. Moreover, the scale of the observation must be taken into account. For example, Figure 37 shows an oblique view of the fracture surface of specimen 3; in this picture, the specimen has been loaded sufficiently to open the crack, but not to cause complete fracture. The highly crystallographic nature of the fracture surface is prominent in this view. Since the crack growth history of this specimen was recorded by photographs, it was possible to locate the crack tip at any time during growth. The plot shows a period of 15,000 cycles during which the crack grew approximately 0.8×10^{-2} mm. During this period, the crack tip showed no growth during two 4,000 cycle periods. This period of arrest corresponds to the time when the crack was attempting

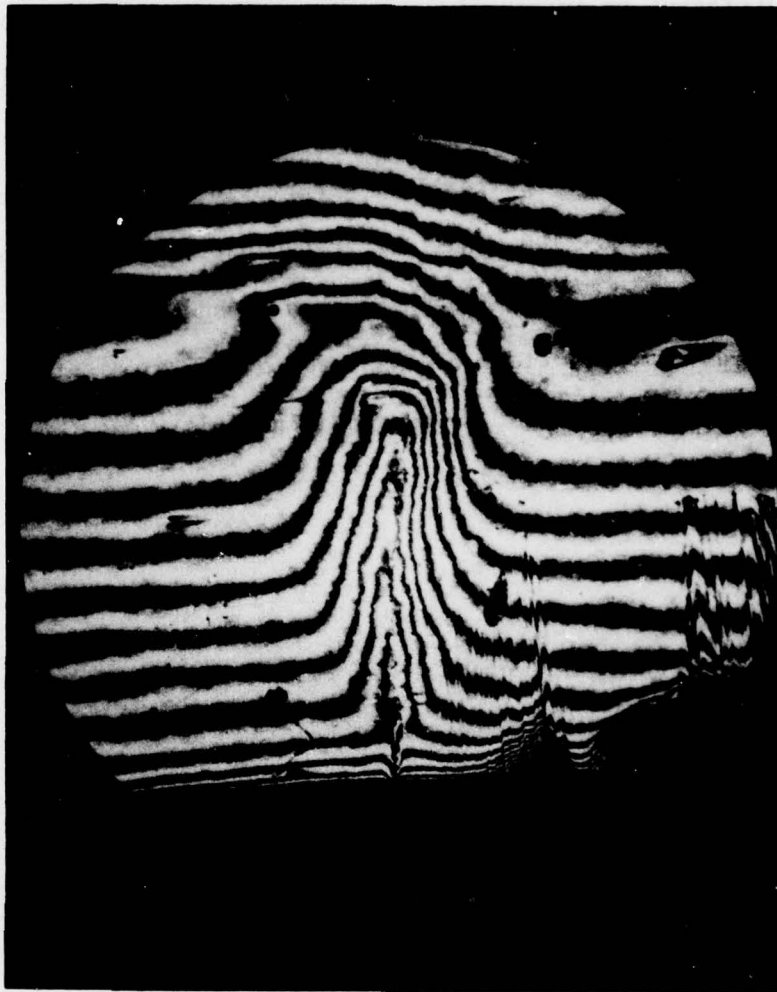
Figure 2A. Interference Micrograph of 0.56 mm Crack in IN-100

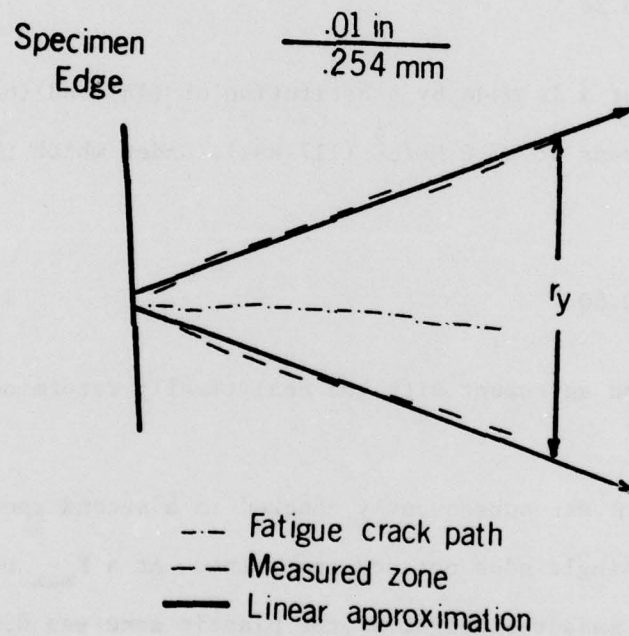
Figure 3A. Deformation Field Carefully Traced From Figure 2A to Indicate Approximations Made
